CALSPAN ON-SITE INADVERTENT AIR BAG DEPLOYMENT INVESTIGATION

CALSPAN CASE NO. 92-8

VEHICLE - 1990 PLYMOUTH ACCLAIM

LOCATION - [REDACTED], GA

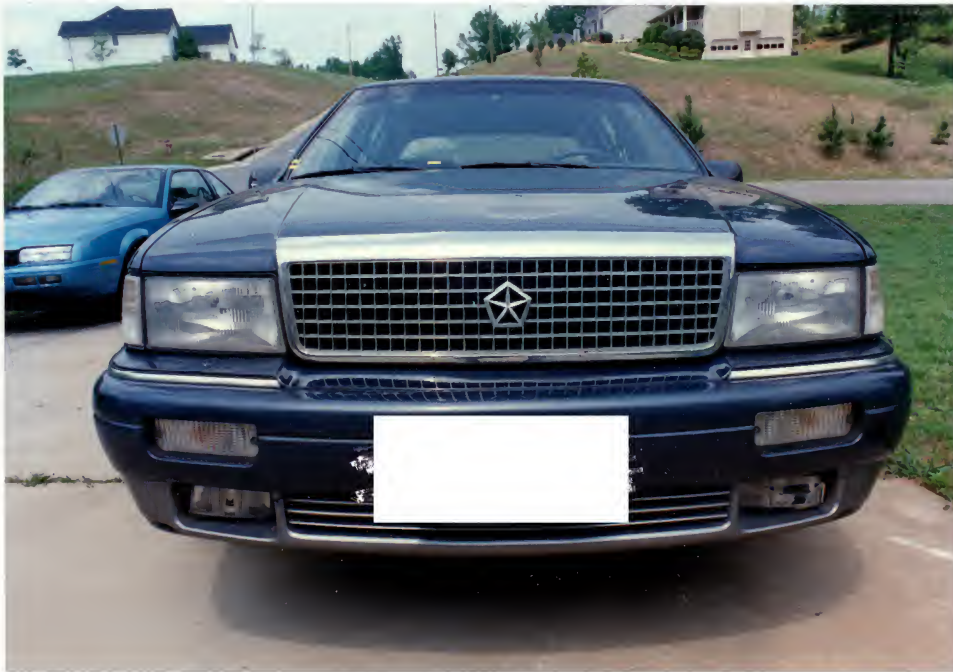
Frontal View Of The 1990 Plymouth Acclaim.

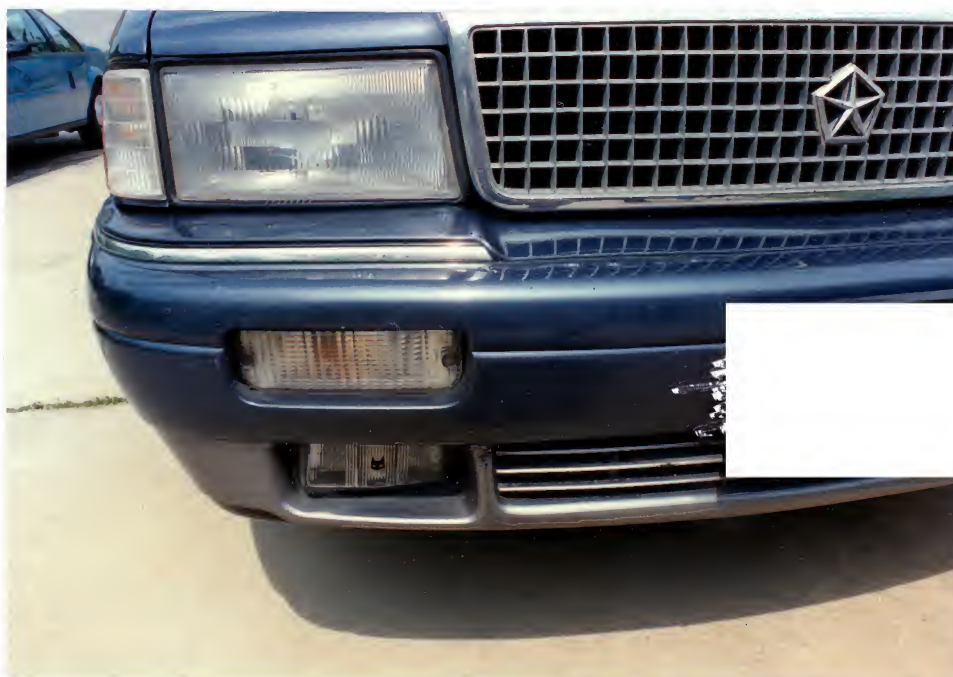
The front bumper fascia did not yield evidence of impact (i.e., scratches, paint transfers, gouges, cracked license plate frame, etc.). The paint at the lower portion of the fascia (painted gray) at the inboard edge of the driving lights was chapped from possible flexing of the lower center fascia. A molded bracket on the lower fascia was not attached to the bumper reinforcement bar. The paint on the top surface of the bumper fascia right of center was peeling from the flexible material. The front bumper energy absorbing devices (EADs) were partially compressed at some point in time and returned to their original positions. The left EAD had compressed 0.25" while the right EAD compressed 0.4" (7/16"). The left driving lamp lens was broken; however, the owners stated that the lens was damaged by a stone approximately one year ago.

Closeup View Of The Right Front Bumper Facia.

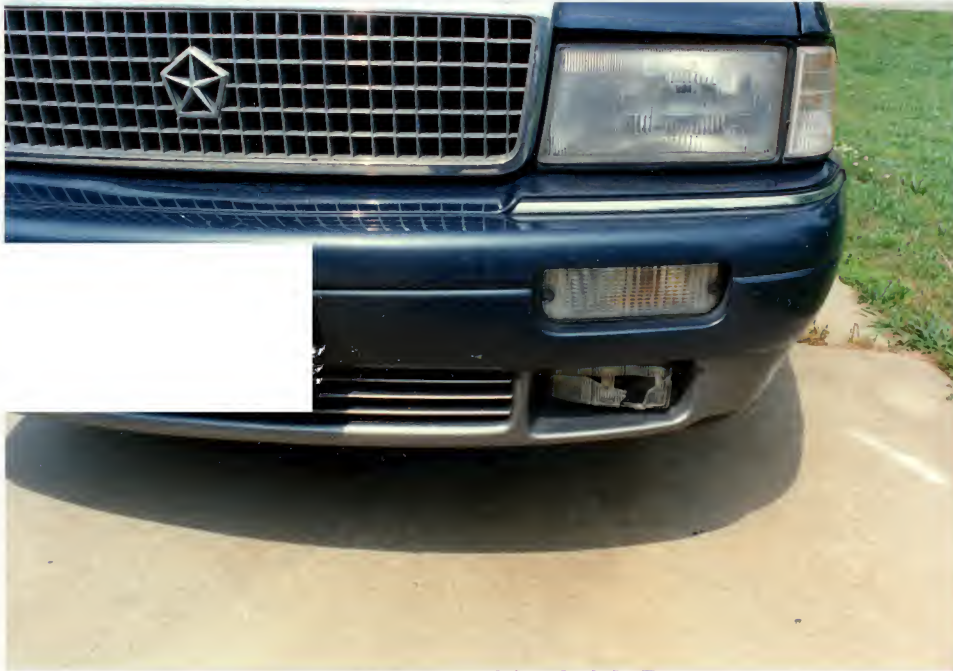
Closeup View Of The Left Front Bumper Facia.

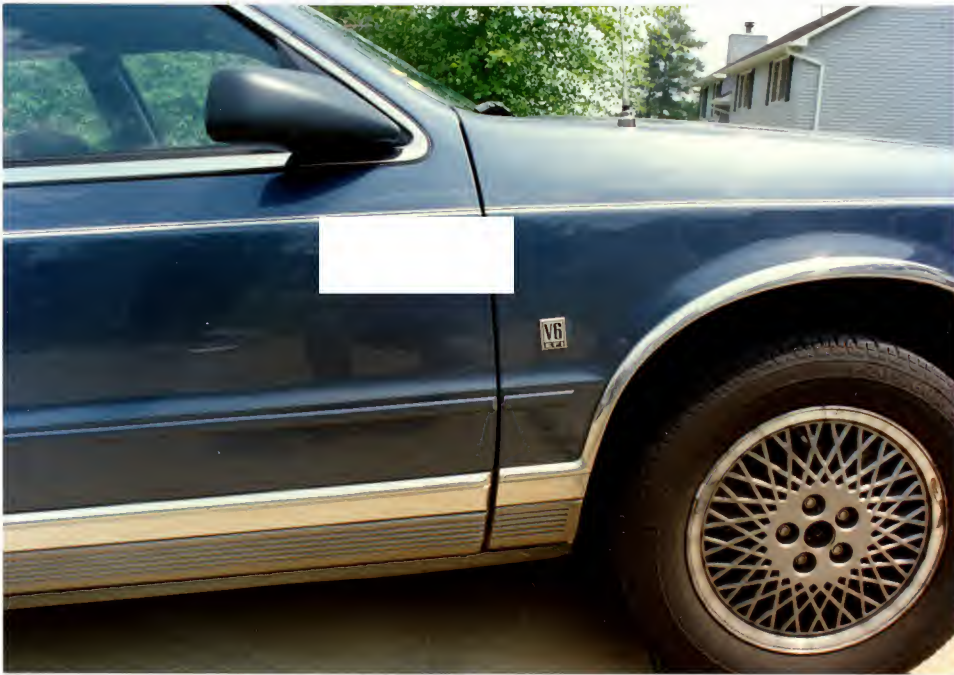
The dealership identified damage to the right front inner fender and to the right front alloy wheel. There was no visible damage to the inner fender area of the vehicle. The owner pointed to a tar-like transfer on the outer edge of the right front wheel which the dealer identified as damage. The transfer was superficial with no deformation or cracks to the alloy wheel. The center plastic dust caps were missing from the left front and right front wheels of the vehicle.

Dealer Documented Damage To The Right Front Wheel.

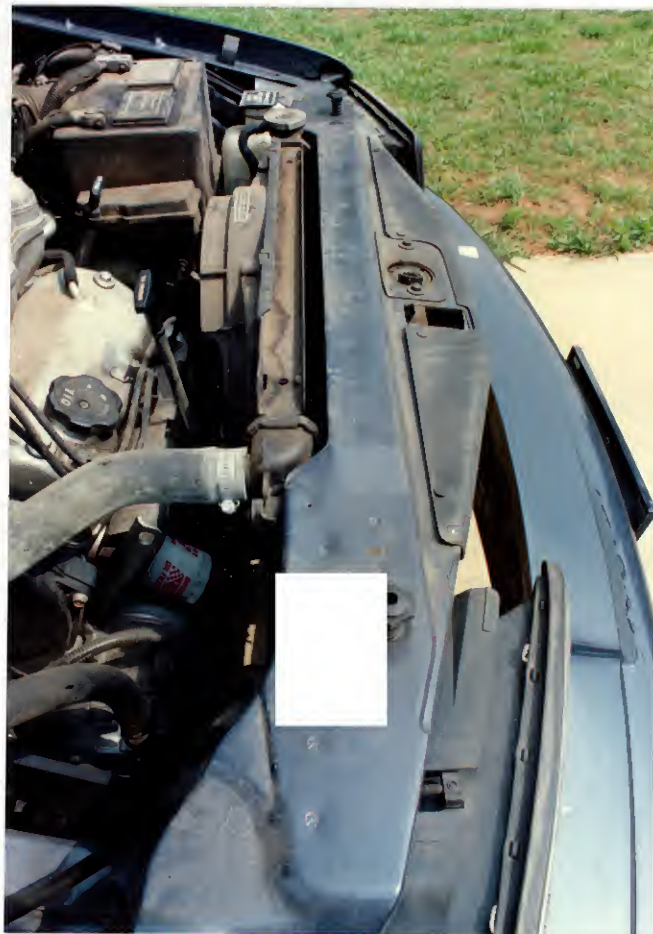
The radiator core support did not appear to be damaged as noted by the dealership during their inspection of the vehicle on [REDACTED] 1992. The upper edge of the core support was straight from fender to fender. The core support appeared to be properly aligned vertically on each side of the radiator. The air bag crash sensors were mounted to this section of the core support and both sensors were properly positioned both vertically and horizontally. There was no damage to the sensors or to the associated wiring or female connectors. The sensors were removed from the vehicle and shipped to NHTSA for additional inspection.

Perpendicular View Across The Upper Core Support.

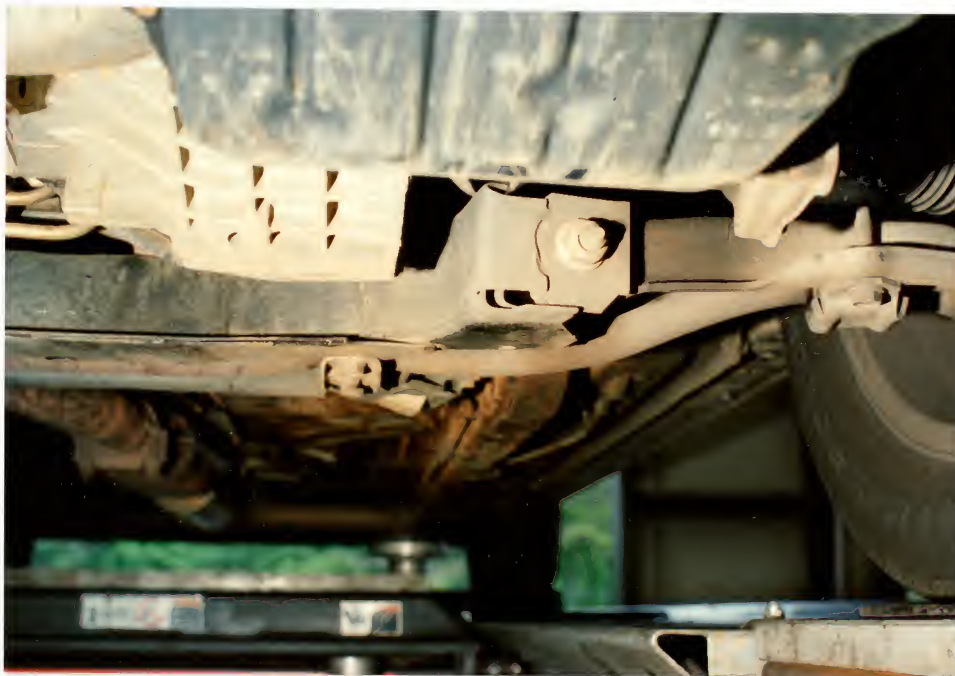
The front crossmember that was located rearward of the engine compartment was not damaged or abraded. A small tissue and hair deposit was noted to the leading edge of the crossmember 8" left of center. The deposits appeared to be fairly recent and probably occurred as the vehicle overrode a small animal. There was no visible damage or displacement of the undercarriage components that would have provided a sufficient longitudinal pulse ($\Delta V \geq 12$ mph) required to deploy the driver air bag system.

Tissue And Hair
On Crossmember

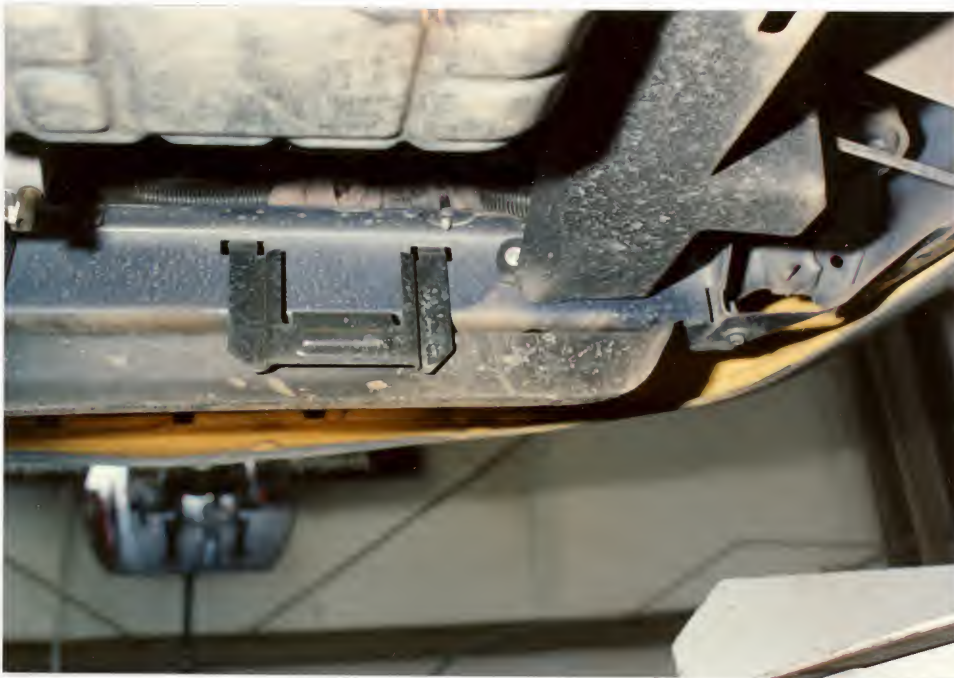
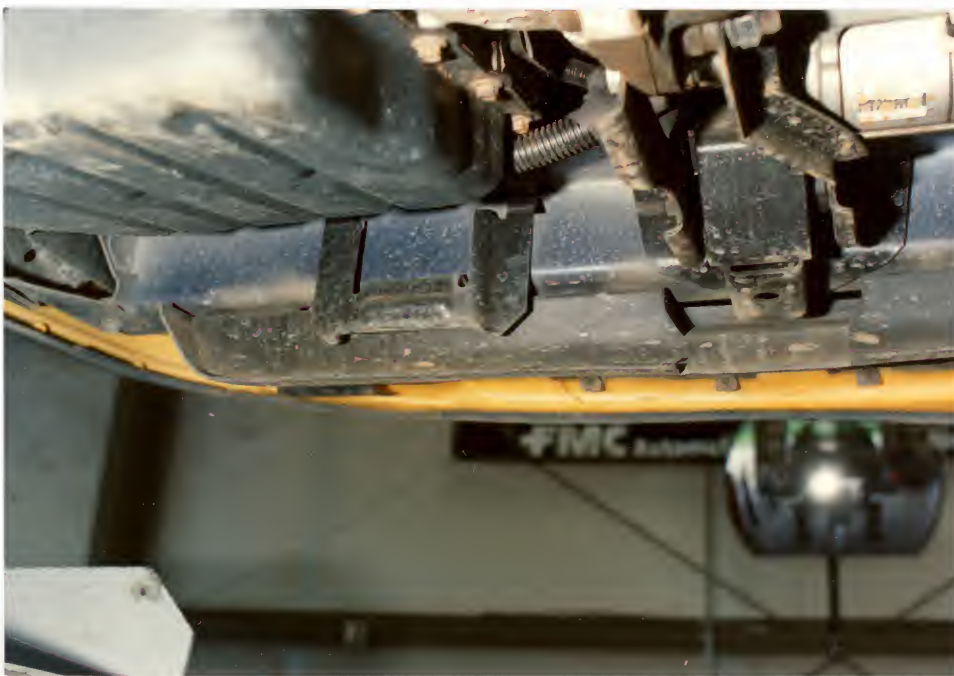
Forward Views Of The Lower Core Support.

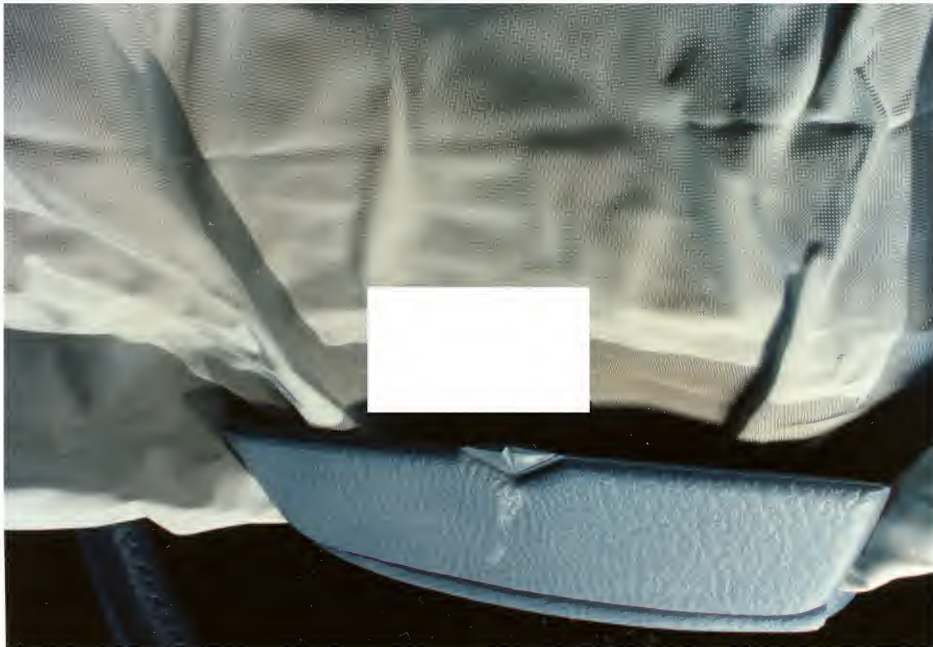
Air Bag Identification Numbers.
